The Rabbit Hole of Improper Alloy Mixes

An amateur collector's journey.

Written by Shawn Tew

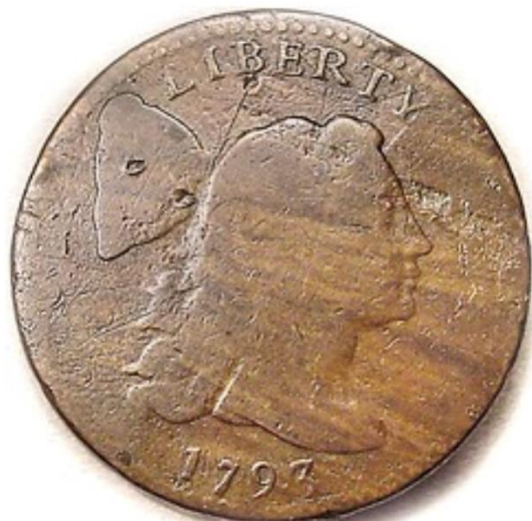
With multiple sources obtained for early copper there are instances where different purities of copper did not mix well when made into blanks. This resulted in a texture to the surface often referred to as a woody. Pictured are a 1793 Sheldon 15 and an 1843 large cent showing the impurities within the copper stock causing the wood grain effect.

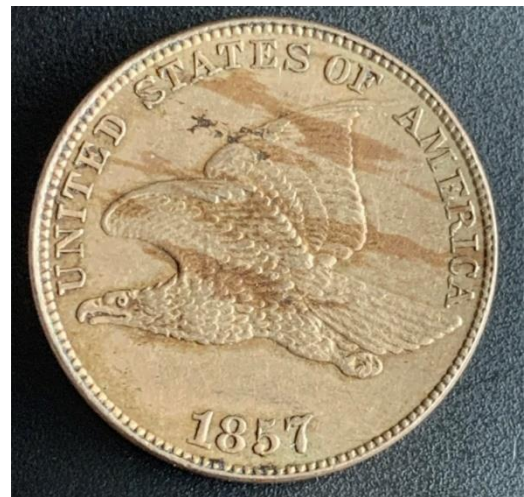
Seen here is an 1857 Flying Eagle showing the improper alloy mix of Copper and Nickel.

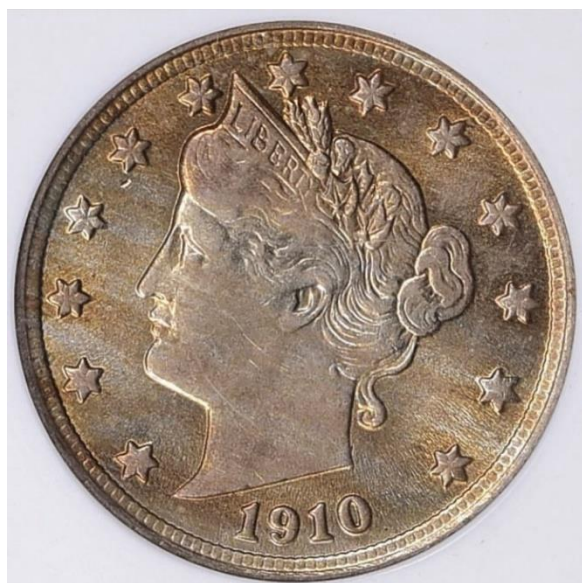
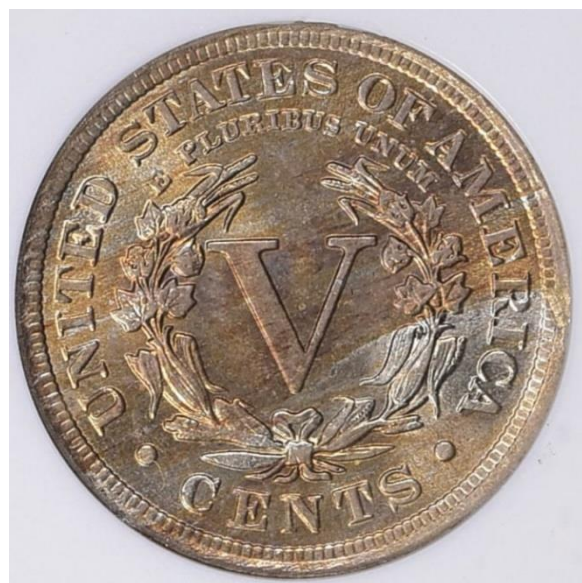
Improper Alloy Mix coins were not limited to just minor copper coinage but also appear in other denominations, as seen in this 1910 V Nickel, until the minting of clad coins begin.

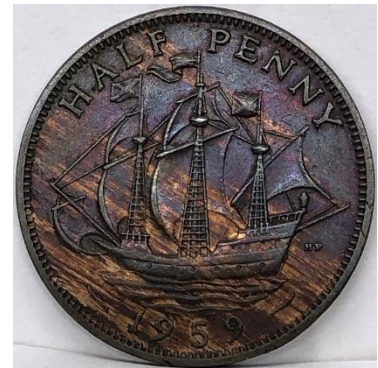
Woodgrain coins are not limited to one country either. They can be found anywhere in the world and can be a challenge to find. This 1959 Half Penny from Great Britain is a great example of an Improper Alloy mix.

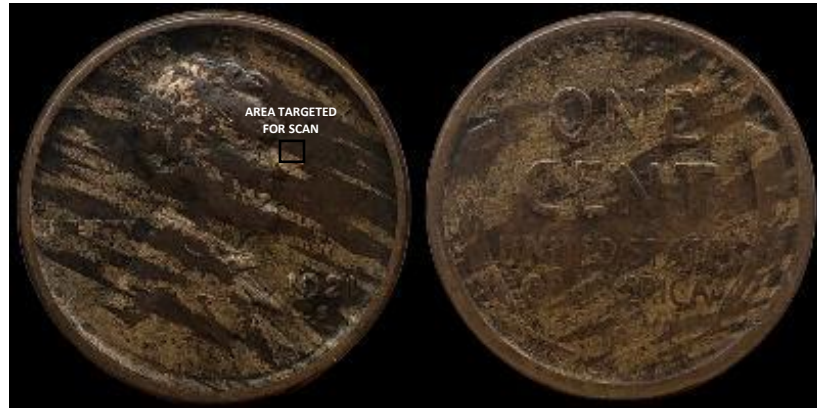
Image 1

A 1921 S was chosen for this scan [Image 1, pg. 38], and two field areas were tested [Image 2, pg. 38]. The darker was in line with the base results [Image 3 and 4 pg. 39] and the lighter areas [Image 5 and 6 pg. 40] once again had elevated tin readings although not as high as tin bronze but enough to resist tarnishing as much as a normal copper alloy.

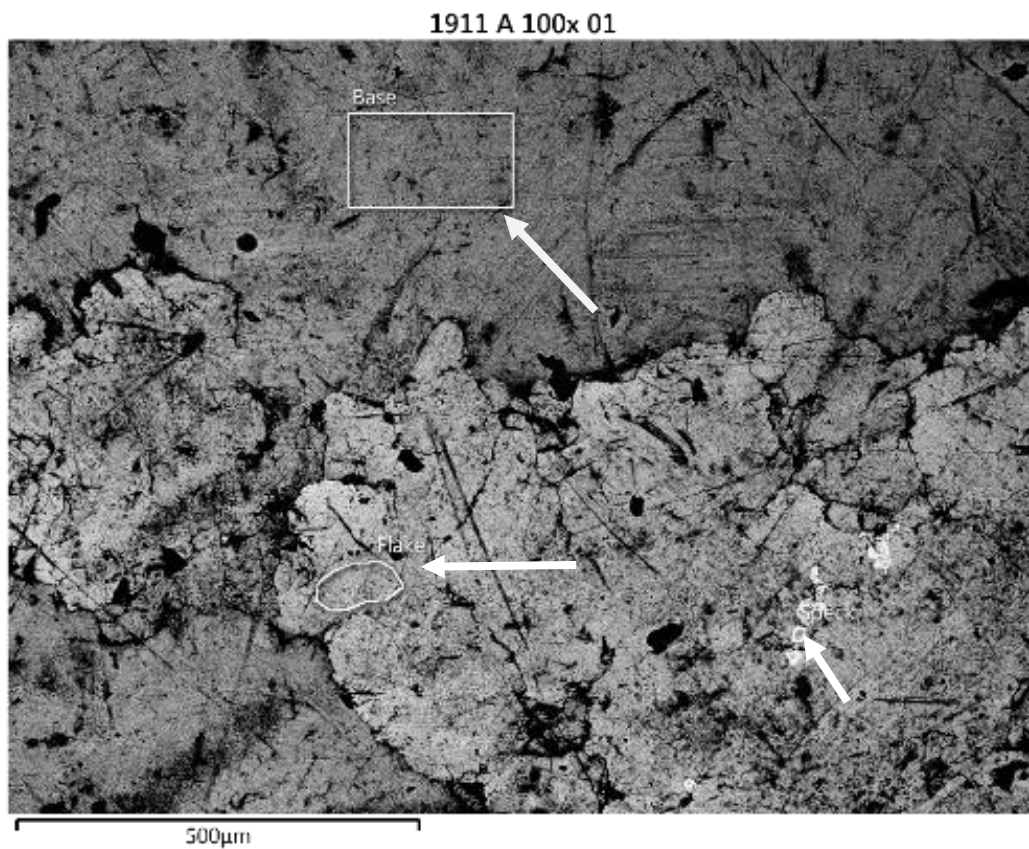
Image 7

In sample 1911 A, three areas were targeted [Image 7]. A base scan of the planchet was performed. The scan labeled base [Image 8, pg.43] resulted in a normal planchet ratio of 95% copper and 5% zinc and tin. The second area scanned labeled FLAKE [Image 9, pg.44] resulted in 86% copper and 11% tin. The third area named SPECK [Image 10, pg.44] resulted in 64% copper and 36% tin.

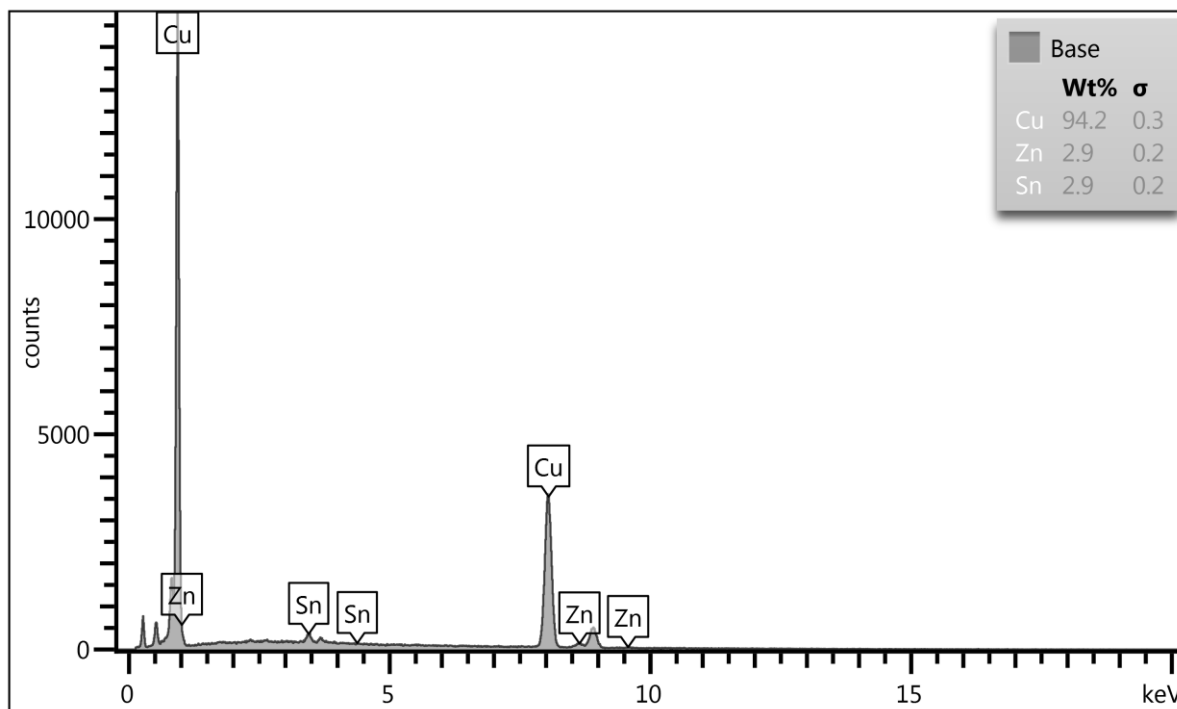
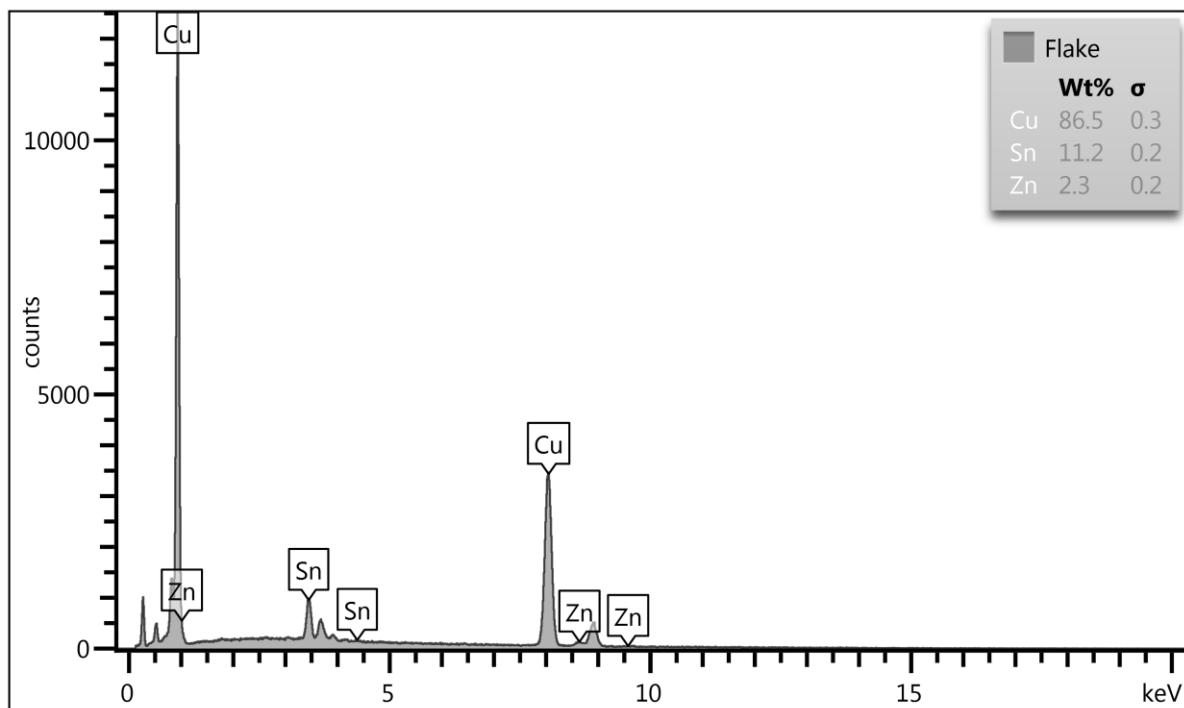
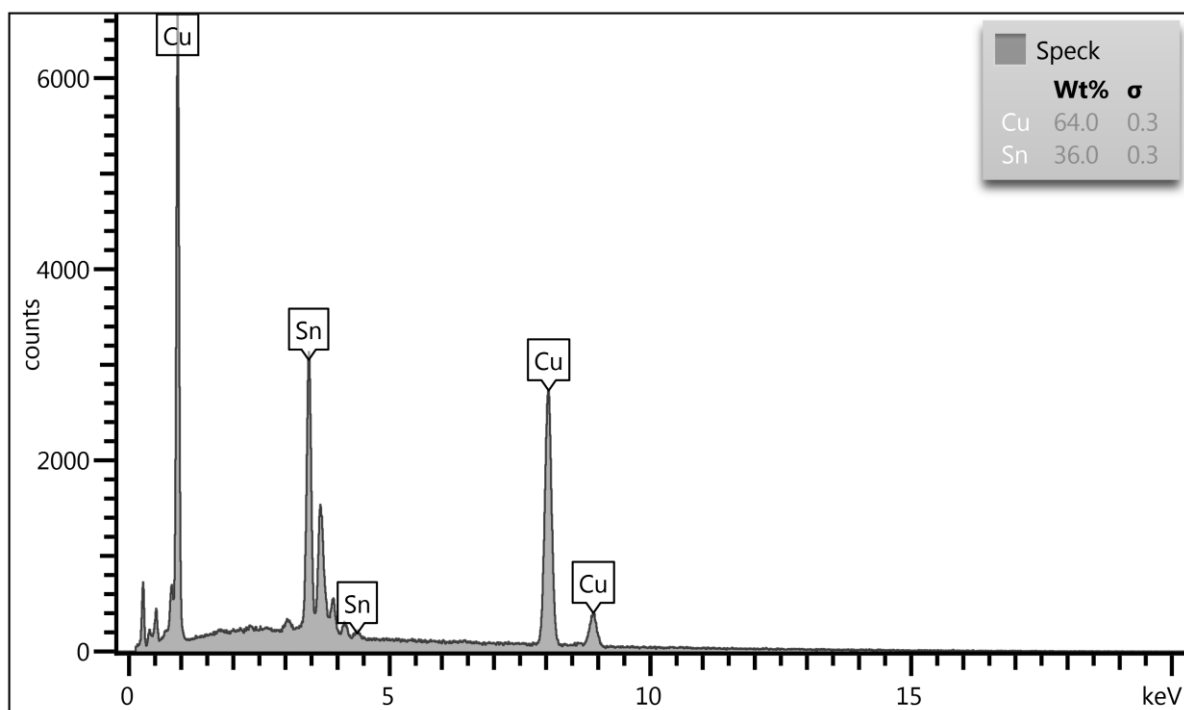
tin compared to their normal alloy mixture of 95% copper and 5% zinc and tin. Within the flakes there were pockets of 60% copper and 35% tin found as well. The tin bronze alloy strengthens the flakes in such a way that the flake becomes less ductile and retains its appearance. Under a 10x scope a separation, like a lamination, can be seen occurring between the flake and the surrounding copper planchet, giving it an appearance that the flake could be removed. The higher-than-normal tin makes the flake less resistant to tarnishing.

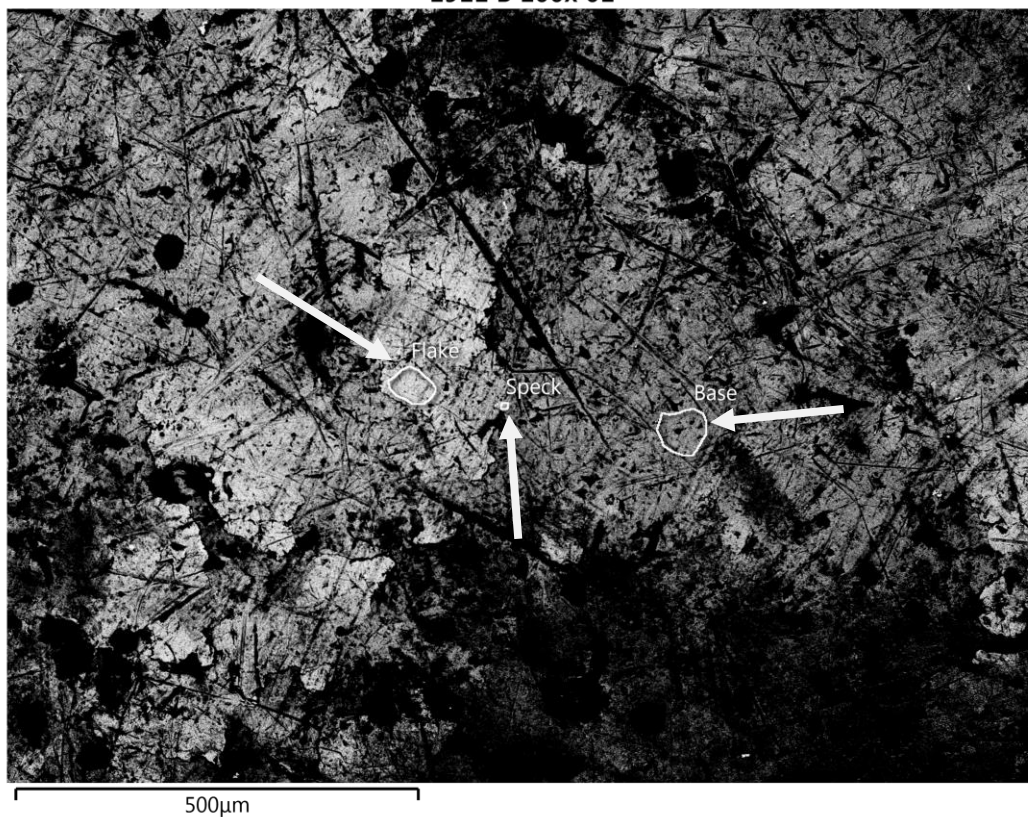
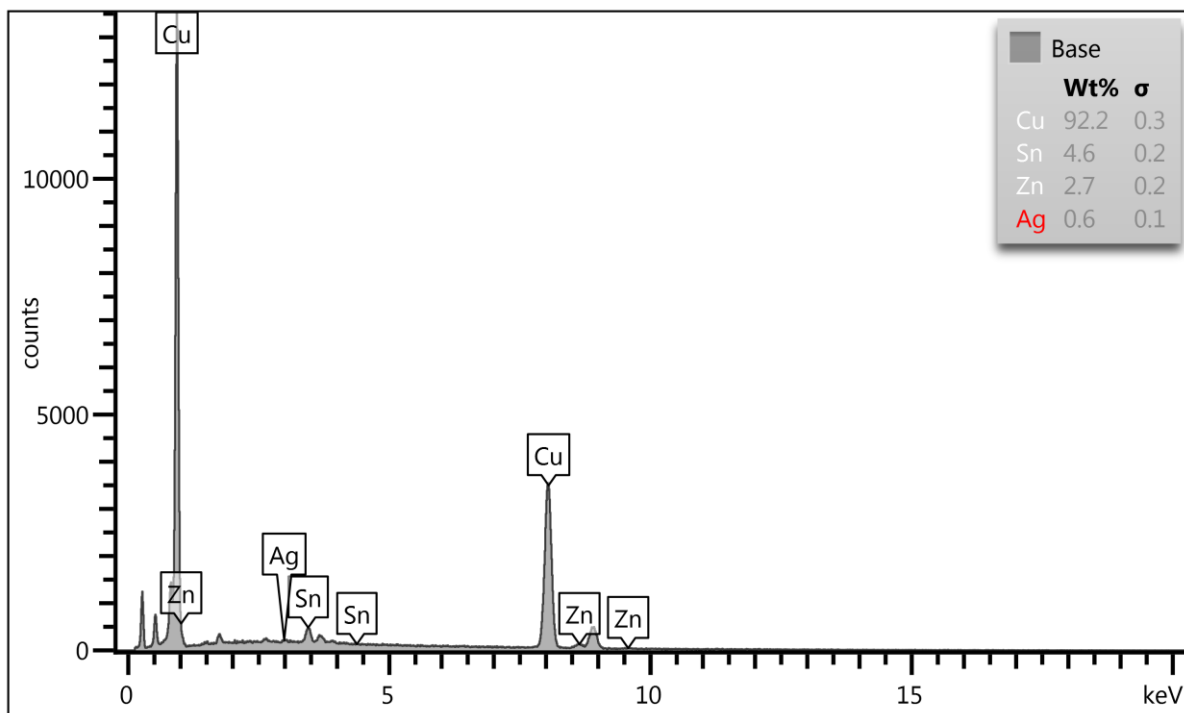
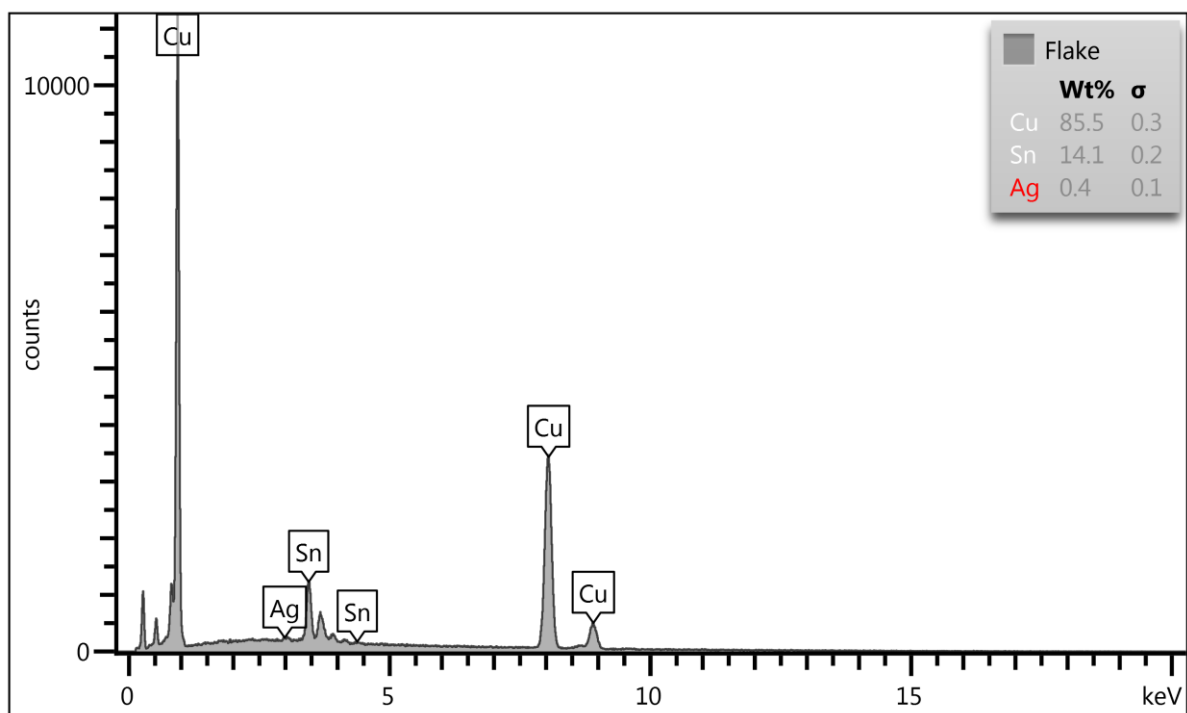
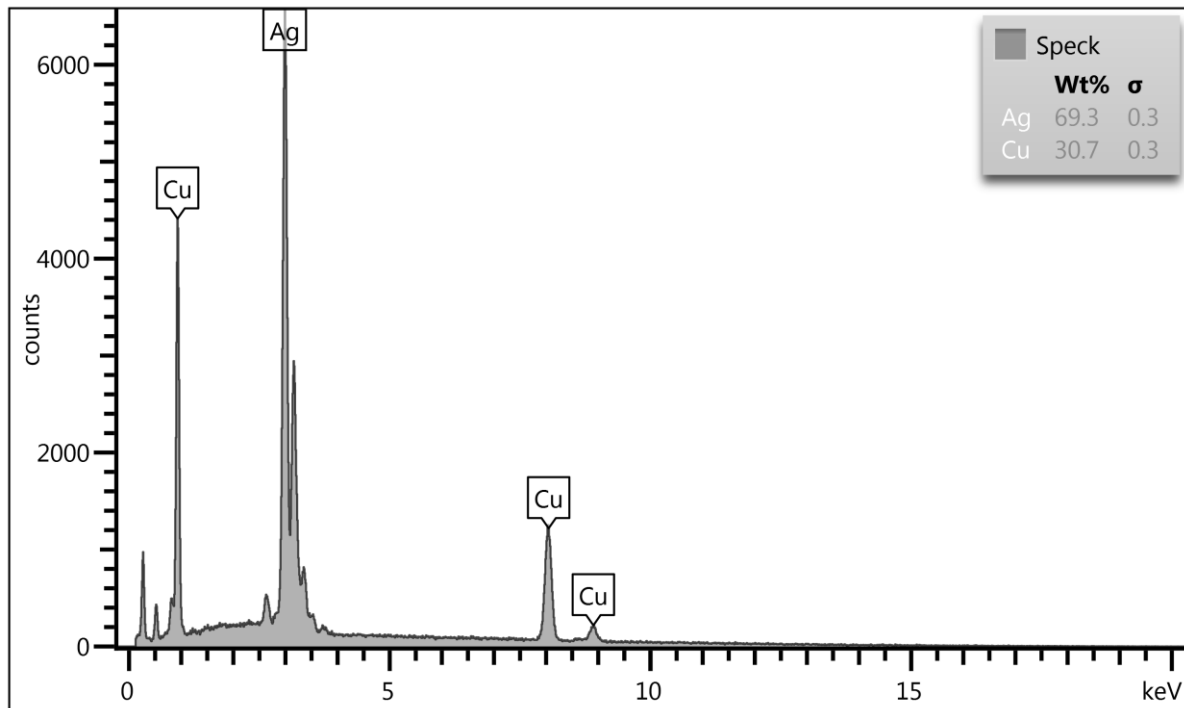
The SEM/EDX scan of Sample 1911 B revealed trace amounts of silver in both the planchet and the flakes. This most likely is due to poor refinery techniques in the copper ore refining process.

Multiple readings were performed in various areas and verified the same results as sample 1911 A.

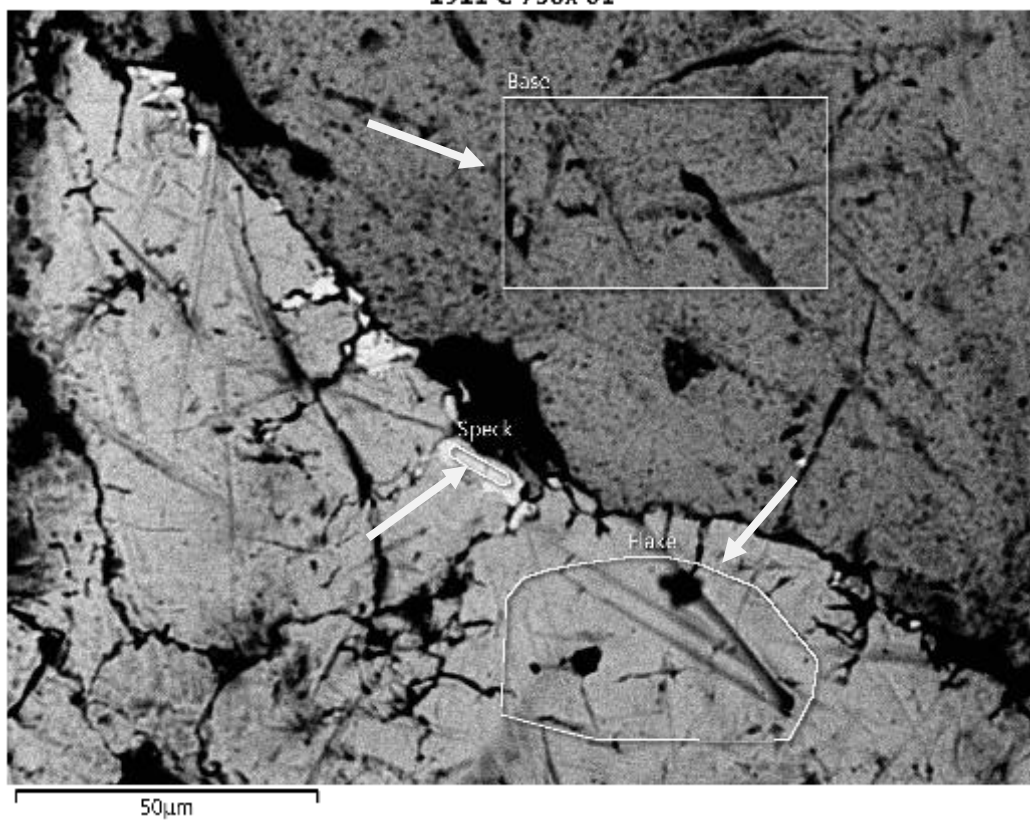
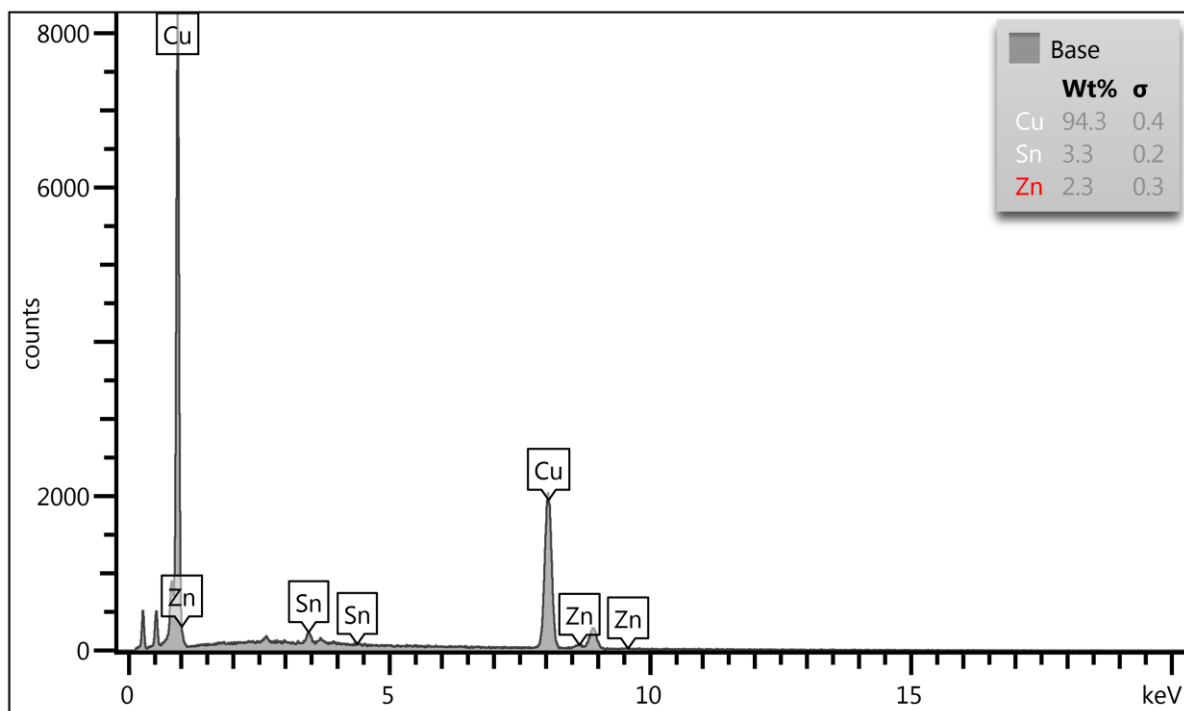
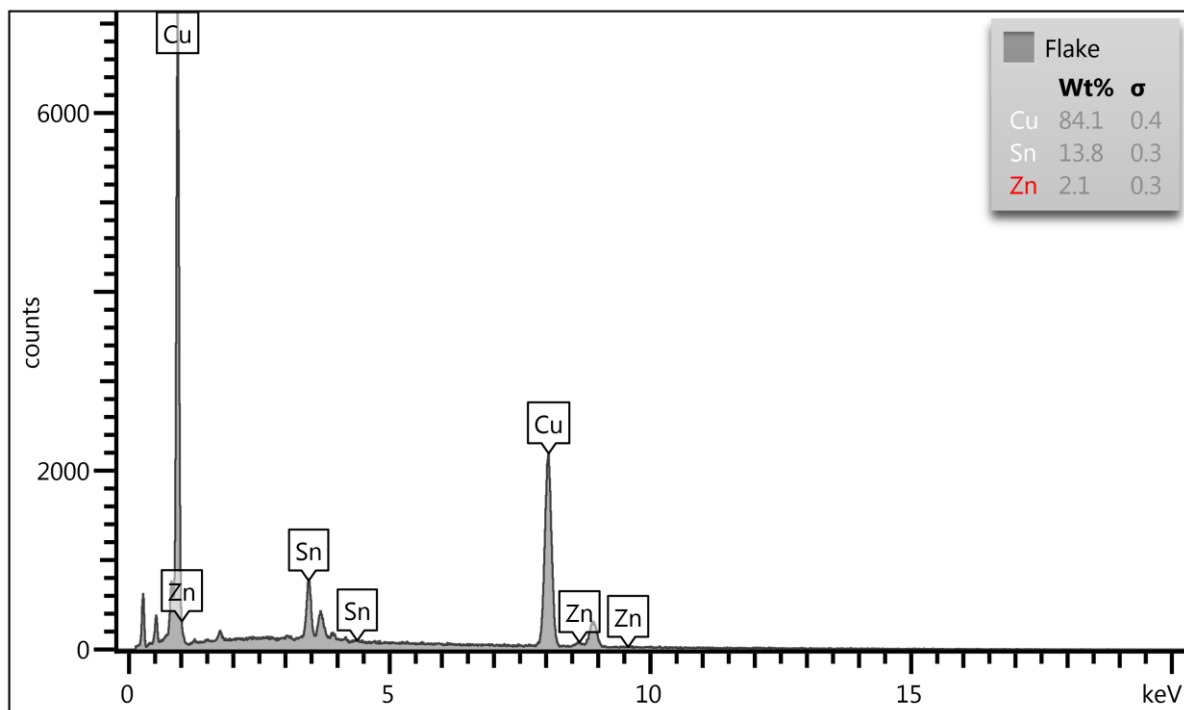
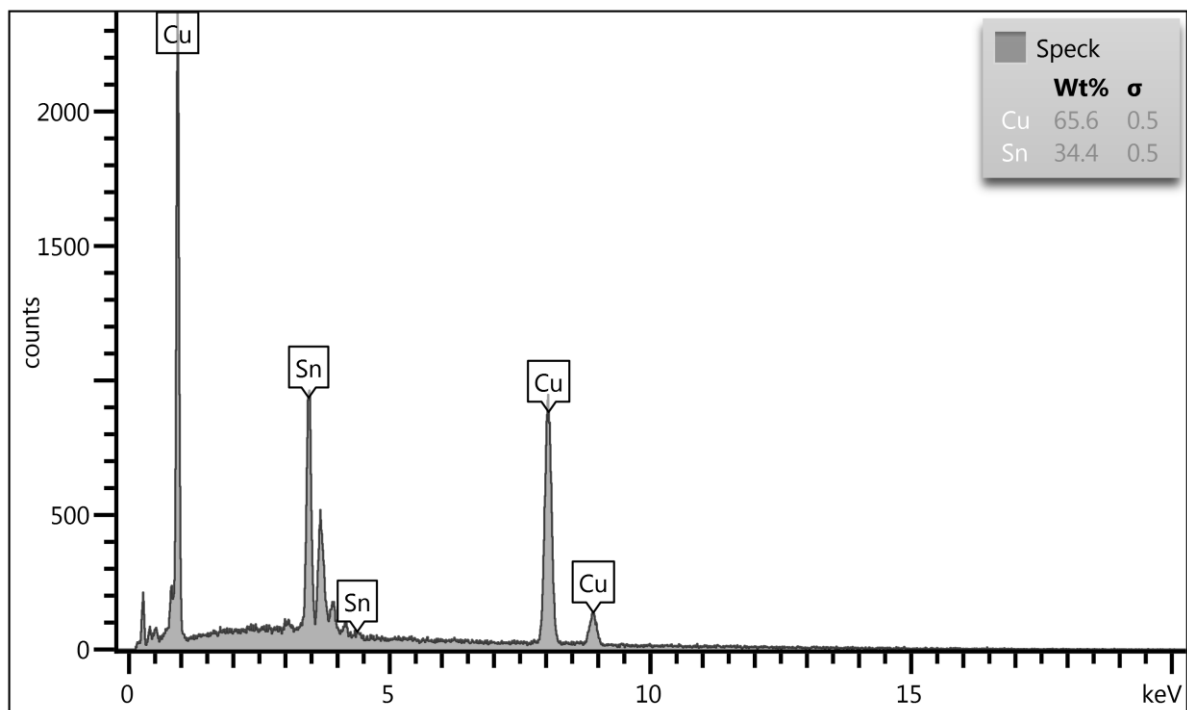
Sample 1911 C

In sample 1911 C scans revealed the same as sample A and B regarding the higher tin ratio.

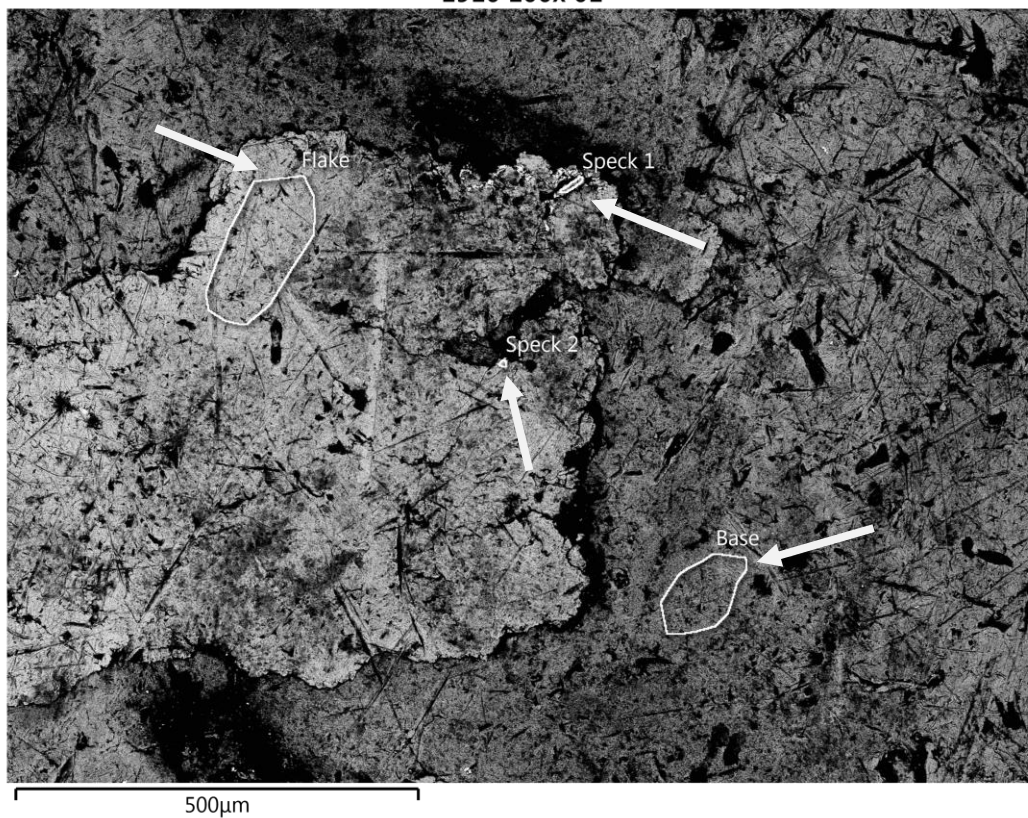
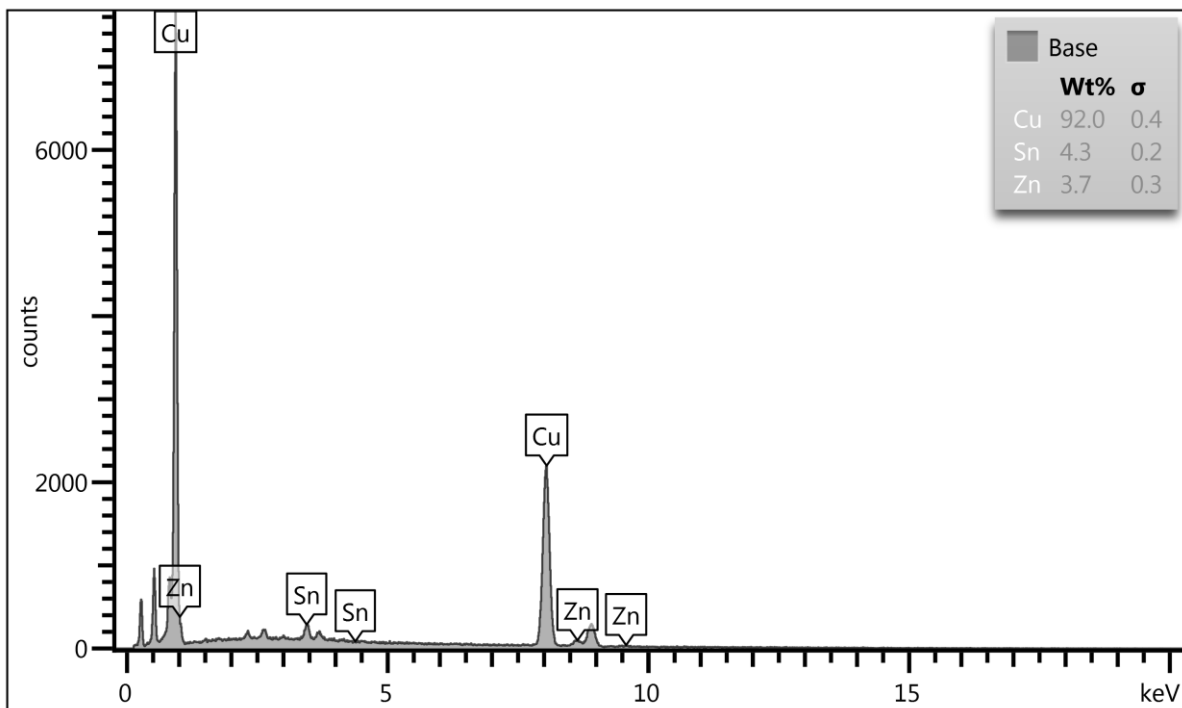
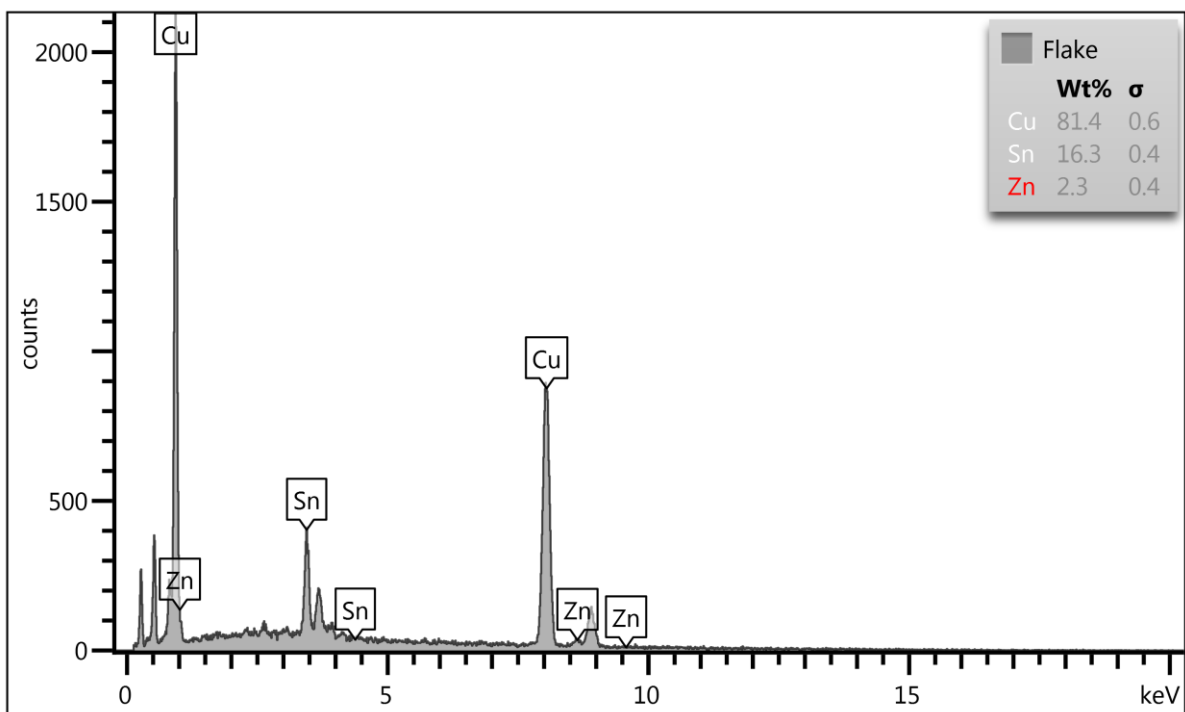
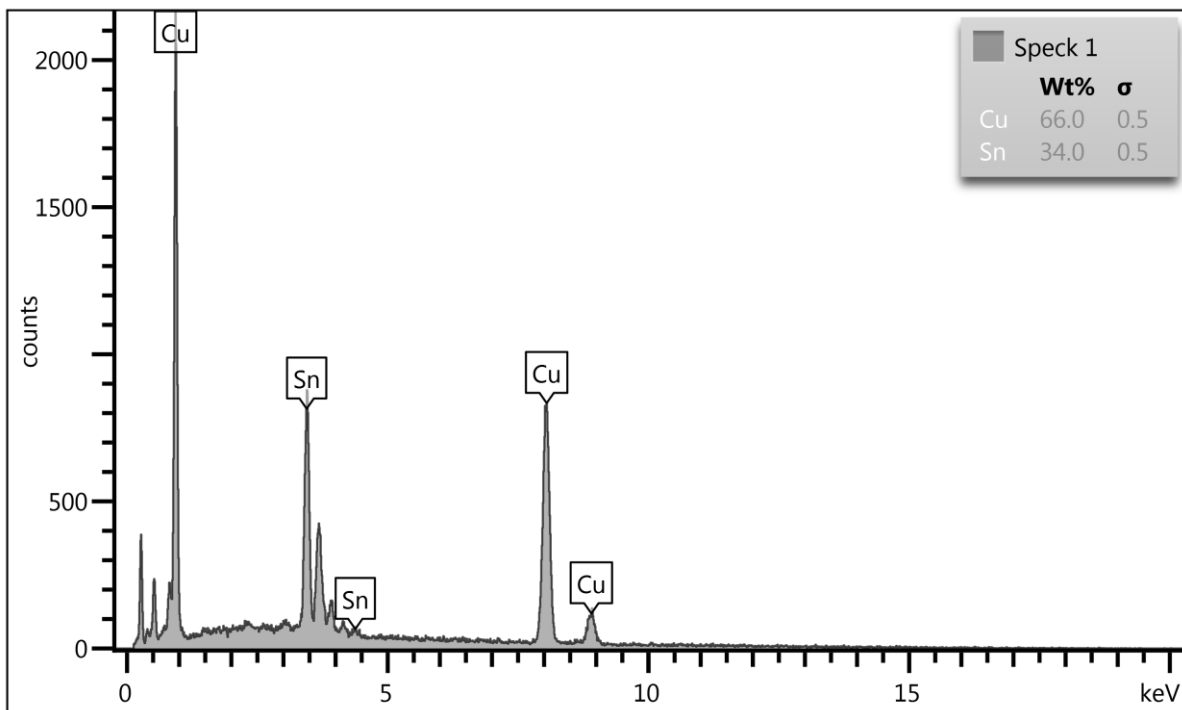
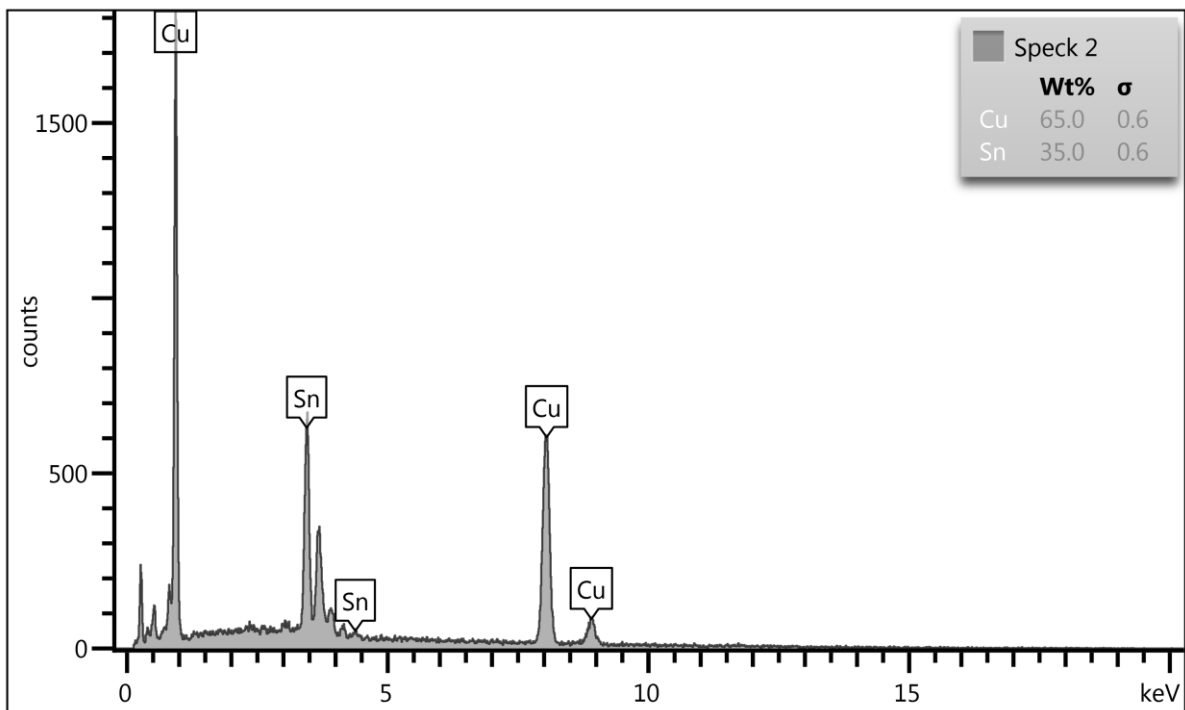
Sample 1910

In sample 1910 scans revealed the exact same findings as the three 1911 samples.

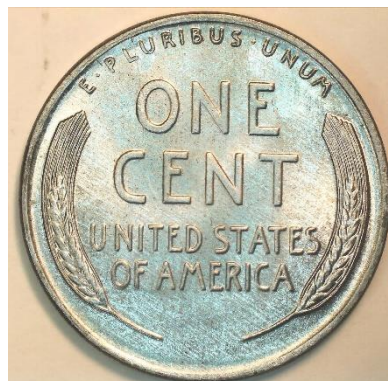
This 1943 owned by Blaine Neupert shows a perfect example of not enough zinc coating being applied over the steel.

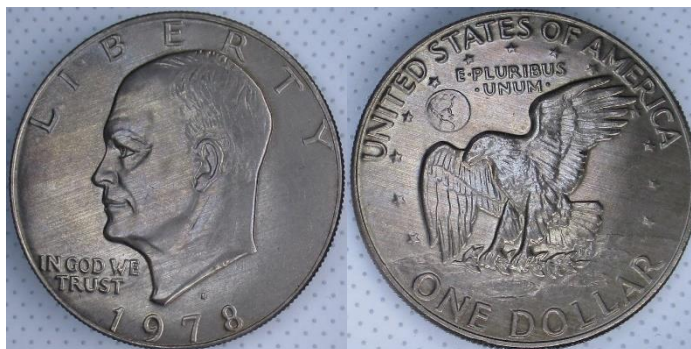
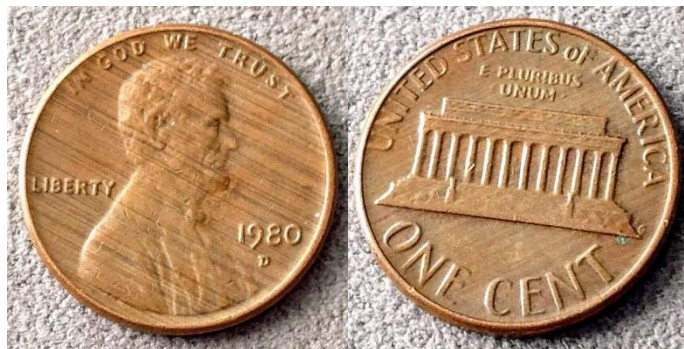
This is in stark contrast to dirty feed rollers that leave a uniform pattern on the surface of the coin making it appear similar to a woodie but has a different cause and effect, as seen on this 1978 D Ike and 1980 D Lincoln (1980 D images courtesy of Joe Cronin). Both sides are oriented in the same direction and have the same appearance.

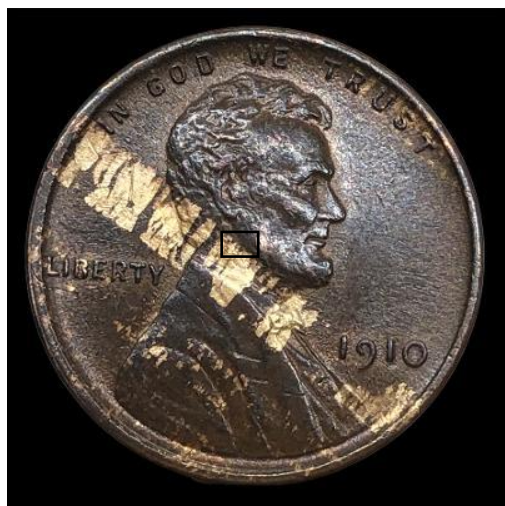
1912s posted by Joe Cronin on Coin Talk 2019

An anomaly was discovered on the obverse side of a 1912s Lincoln wheat cent and posted April 13, 2019 by Joe Cronin on the discussion boards of Cointalk.com. The coin shows what appears to be chunks of brass colored metal embedded into the surface. This led to speculations ranging from the alloys used to make the copper blanks not mixing correctly to metal falling onto the surface, possibly gold, and being rolled in.

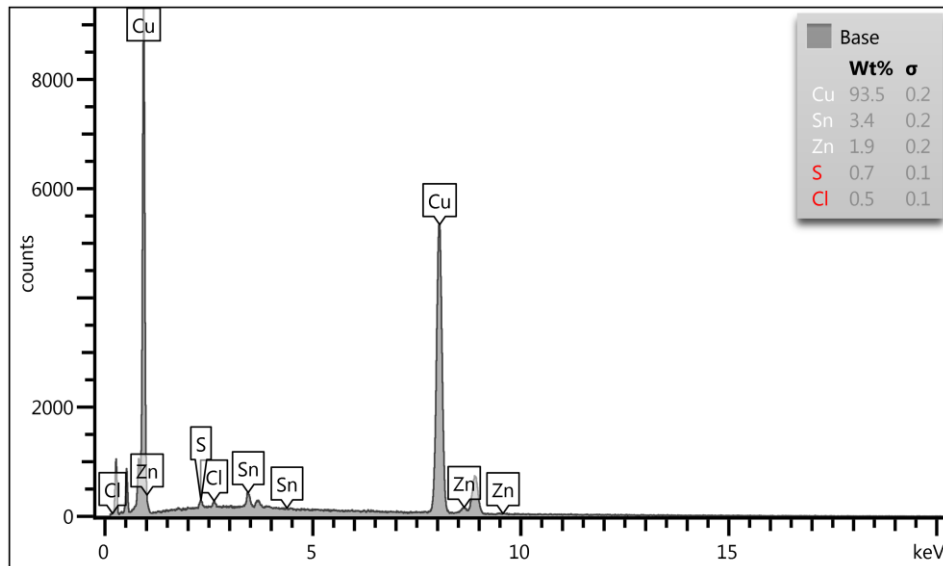
Image 1

and within that box two areas were targeted. The area labeled BASE [Image 1] was used for a control sample and showed normal tarnishing of a Lincoln cent. It shows a normal mixture of copper, tin, and zinc. The second sample is marked STRIPE [Image 2] and again has a higher than normal tin reading creating a tin bronze alloy that is tarnish resistant.

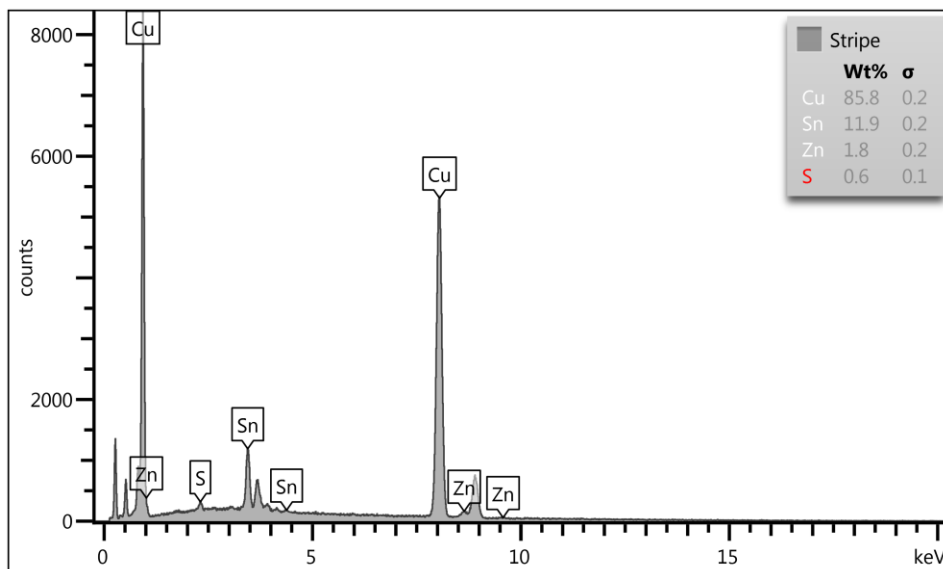
Image 2

Although these coins are categorized as Woodies they are not an improper alloy mix as the metal has fallen onto the surface of the rolled stock and been pressed into the surface of the planchet before entering the striking chamber.

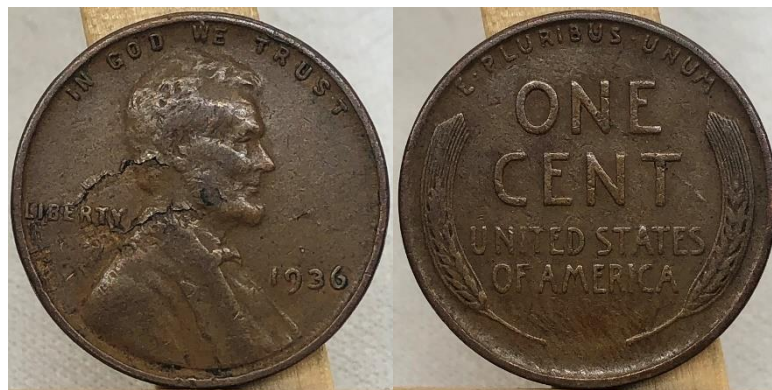
LAMINATION CRACK

There are multiple errors caused by side effects of improper alloy mixes. These can be identified as lamination crack, lamination peel, detached lamination peel, split clamshell, detached clamshell, and split planchet. These errors are not exclusively caused by improper alloy mixes but may also be caused by contamination from water, grease, and dirt.
